Re: Parking Garage Visual Observation Report
Oak Park & River Forest High School
Oak Park, IL
LEI Project No: 21160231.000

VISUAL OBSERVATION OF THE
OAK PARK & RIVER FOREST HIGH SCHOOL PARKING GARAGE
201 N SCOVILLE AVE
OAK PARK, ILLINOIS 60302

LEI PROJECT NO. 21160231.000

MAY 4, 2016

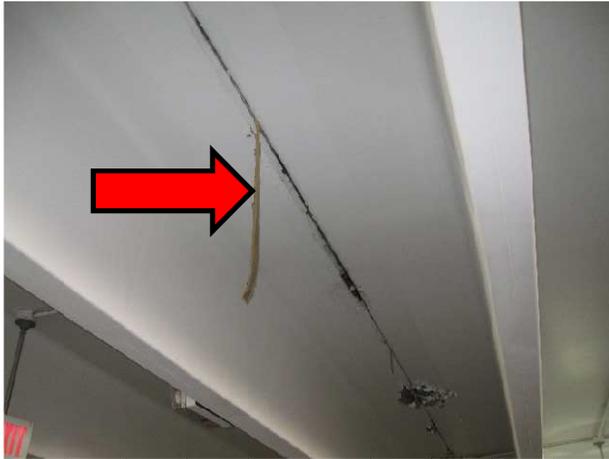
1. Deteriorated and/or damaged sealant was observed at the underside of the precast double-T beams along the joints between sections (photo 01). This observation was typical through the structure. In multiple locations open joints between sections were observed. Adjacent to the areas of damaged sealant, water damage and peeled paint were typically observed (photo 02). At multiple areas throughout the structure chipped and peeling paint was observed on the concrete structure in what appeared to be water damage.

01
Deteriorated
sealant at
double-T
joint

1. Sealant at precast double-T beams should be replaced. Damaged or deteriorated sealant at coping panels as well as at deck-to-column interface locations and wall-to-column interface locations should be replaced. The damaged and deteriorated sealant appears to be causing paint to peel and chip at the precast double-T sections and spandrel beams at the underside of the deck. The peeled and chipped paint at concrete beams did not appear to be indicative of any structural deficiencies. If required for aesthetic purposes, areas of damaged paint can be scraped and repainted.
Estimated Length of Sealant Repair: 7800 LF
2. Spalled and cracked concrete corbels should be patched and repaired with an approved patching compound. Remove all loose concrete including chipping at reinforcement,

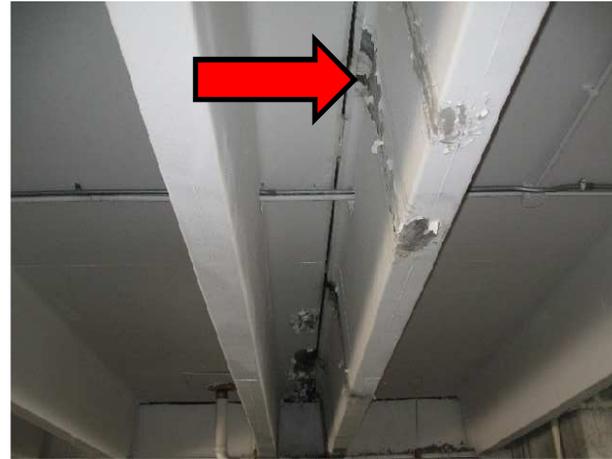
02
Water
damage
and peeled
paint

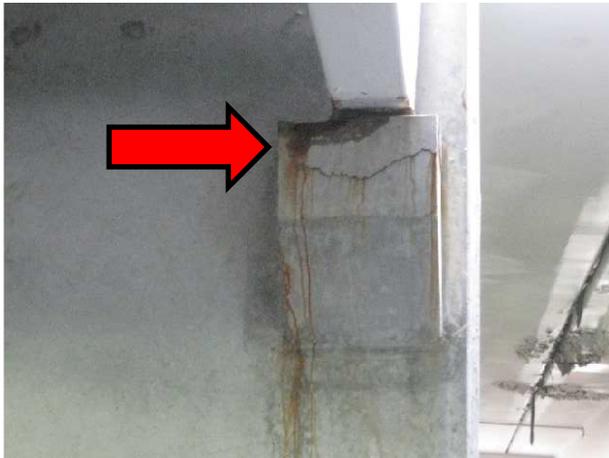
2. Spalled and cracked concrete was observed at multiple corbels throughout the structure. We also observed corrosion at the steel embed plate supporting the precast double-T beams at the corbels (photo 03). At multiple corbels on the north side of the parking garage, the double-T section was only partially bearing on the corbel (photo 04).

03
Spalled and
cracked
corbel with
corroded
embed plate

clean and remove any corrosion, prime and paint any exposed or corroded rebar or corroded embed plates with a rust-inhibitive paint prior to patching the adjacent concrete. If significant section loss occurs at rebar or embed plate, or if delamination is observed, the rebar section or embed plate should be replaced.

Estimated Area of Concrete Patching: 100 SF

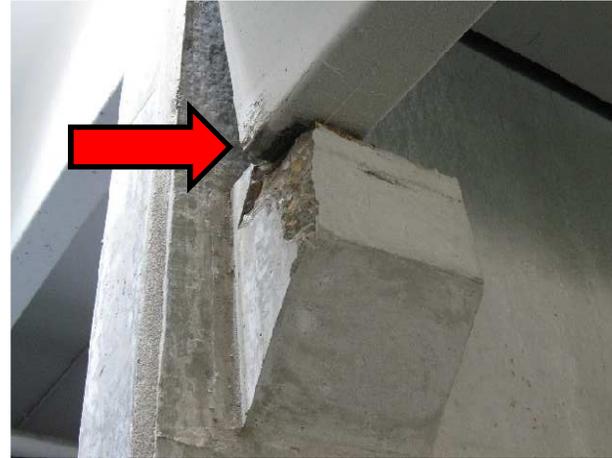
Observation items 2 and 4 represent structural deficiencies that should be addressed to ensure the short-term integrity of the parking structure. The remaining observation items do not necessarily indicate structural deficiencies; however failure to address these items in a timely manner could result in compounding issues that could eventually have a negative impact on the structural integrity of the parking garage.

04
Double-T
partial
bearing at
corbel

At corbel locations where the bearing width of the double-T section is less than 2/3 of the width of the double-T web, rebuild the corbel and reinforce with a steel saddle.

Estimated Quantity of Corbel Replacements: 2 EA.

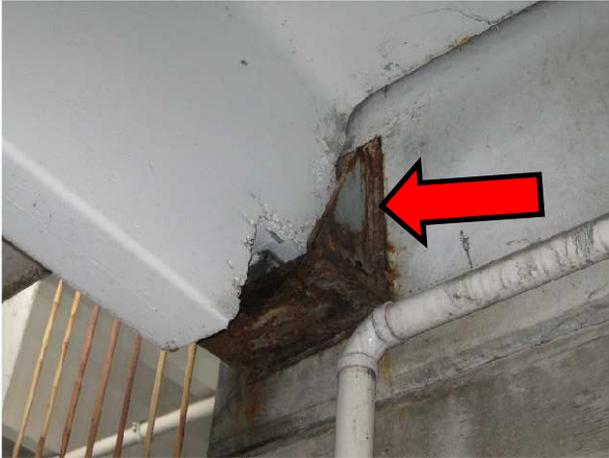
3. At four (4) locations on the north side of the parking garage, steel saddles were used to anchor the double-T sections to the precast walls in lieu of the concrete corbels provided elsewhere. All of the steel saddles were corroded (photo 05).

05
Corroded
steel saddle

3. Corroded steel saddles should be cleaned and removed of any corrosion. Saddles should then be primed and painted with a rust-inhibitive paint. If significant section loss occurs, or if delamination is observed, the steel saddle should be replaced.

Estimated Quantity of Steel Saddle Replacements: 1

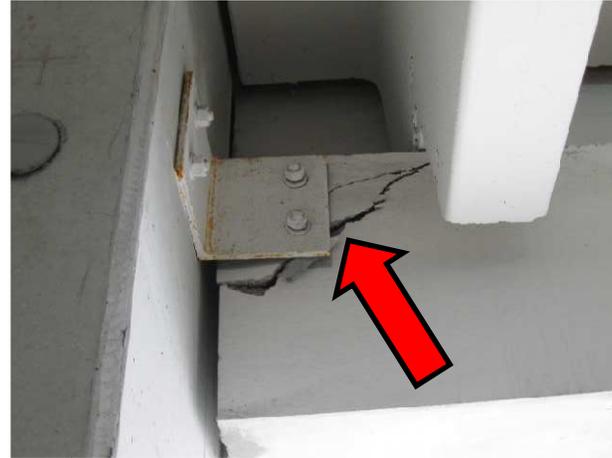
4. Spalled and cracked concrete was observed at a perimeter beam support on the lower level of the north side of the parking garage. The spalled and cracked concrete was observed directly adjacent to anchor bolts connecting the beam to a steel angle (photo 06). We also observed spalled concrete at the underside of multiple perimeter beams (photo 07).

06
Spalled and
cracked
concrete at
beam
anchor
point

4. The damaged end of the concrete girder at the lower level of the north side of the parking garage should be repaired. Concrete should be chipped away in the girder section adjacent to the damaged section to determine the extent of the damage and to identify any areas of rebar corrosion. The full scope of repairs can be assessed once this is complete.

Partial Girder Reconstruction Quantity: 1

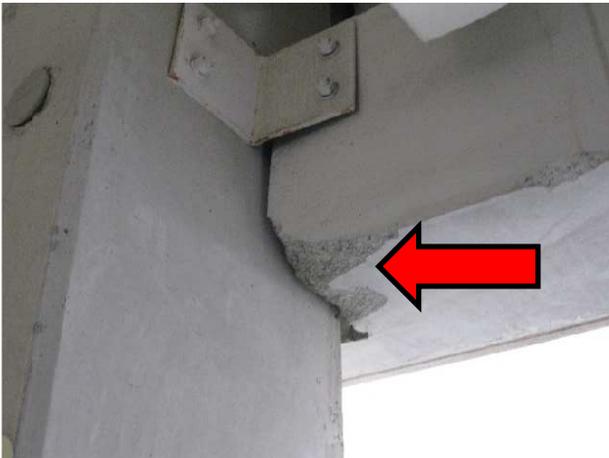
07
Spalled
concrete at
underside
of beam

Local areas of spalled concrete at the perimeter beams where rebar is exposed should be patched and repaired with an approved patching compound. Loose concrete should be removed. Exposed and corroded rebar should be cleaned and any corrosion should be removed. Exposed rebar should then be primed and painted with a rust-inhibitive paint prior to patching the surrounding concrete.

Estimated Area of Concrete Beam Patching: 20 SF

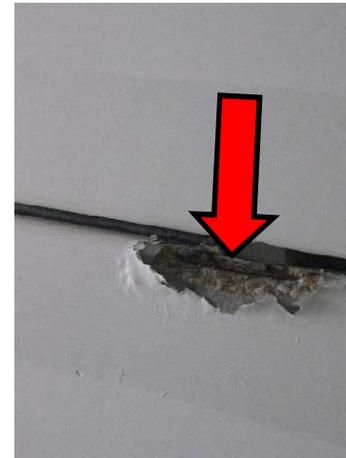
5. Corroded steel connector plates were observed at the precast double-T beam joints as well as at the expansion joints (photo 09). This observation was typical throughout the structure with the steel plates displaying varying levels of corrosion. The steel connector plates were generally only visible when the joint sealant was deteriorated or missing. In some locations we observed local areas of spalled concrete in the precast beam flange adjacent to the corroded steel plates. Exposed and corroded rebar were also observed at multiple areas of spalled concrete in the double-T beam flanges (photo 08).

08
Exposed
and
corroded
rebar at
double-T
beam flange

Spalled concrete at precast double-T beam flanges should be patched and repaired with an approved patching compound. Loose concrete should be removed. Any exposed rebar should be cleaned and any corrosion removed, exposed rebar should then be primed and painted with a rust-inhibitive paint prior to patching the surrounding concrete. Areas of minor spalling where rebar is not exposed may not require patching.

Estimated Area of Precast Double-T Beam Patching: 65 SF

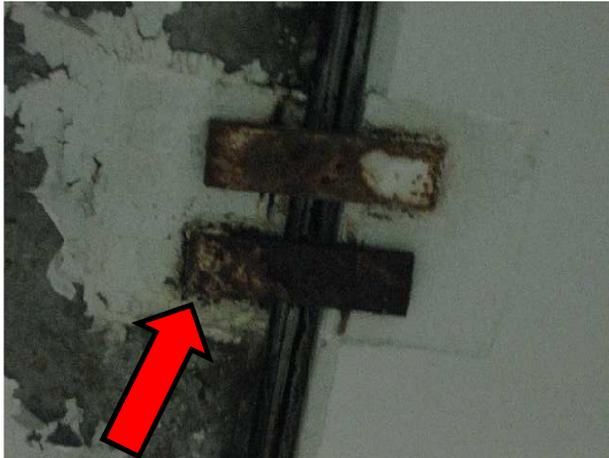
09
Corroded
connector
plates at
expansion
joint

5. Corroded steel connector plates at expansion joints should be cleaned and any corrosion removed, plates should then be primed and painted with a rust-inhibitive paint. If significant section loss occurs, or if delamination is observed, the plate should be replaced. Areas of light corrosion observed at double-T joint connector plates and spandrel beam shelf angles should be cleaned and painted with a rust-inhibitive paint where needed. The areas of corrosion at the double-T joint connector plates in some locations appear to be resulting in local areas of concrete spalling at the precast double-T flanges and should therefore be addressed to prevent further damage to the concrete.

Estimated Expansion Joint Plate Replacement: 6 EA.

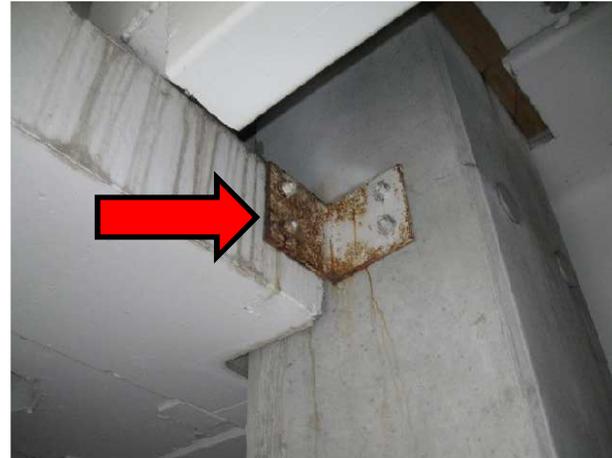
6. Corroded steel angles were observed at the ends of multiple perimeter concrete beams throughout the parking garage (photo 10). Corroded steel shelf angles were also observed at multiple spandrel beams (photo 11). At one end of a perimeter concrete beam on the lower level of the north side of the parking garage, we observed missing anchor bolts at the steel angle that anchors the beam to a concrete column (photo 12).

10
Corroded
steel angles
at beam-to-
column
connection

6. Corroded steel end angles anchoring concrete spandrel beams to concrete columns should be cleaned and any corrosion removed, angles should then be primed and painted with a

rust-inhibitive paint. If significant section loss of the angle occurs, or if delamination is observed, the angle should be replaced.

Estimated Quantity of L6x6x3/8x0'-6" Replacement: 4 EA.

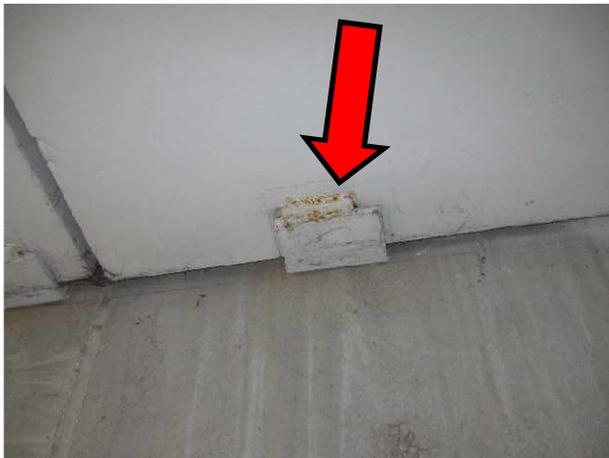
11
Corroded
shelf angle

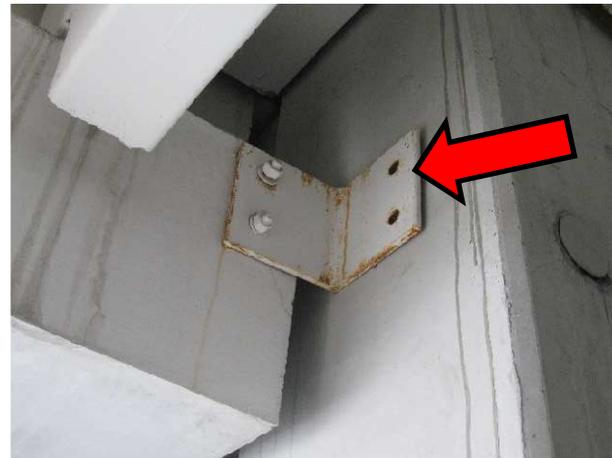
12
Corroded
steel angle
with missing
anchor bolts

Corroded or missing anchor bolts should be replaced.

Estimated Quantity of Anchor Bolt Replacement: 6

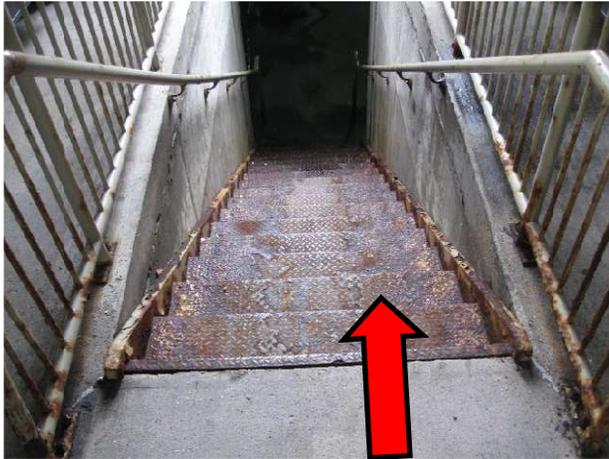
7. Corroded stair treads and handrails were observed at the stairway connecting the lower level on the north side of the garage to the ground level segment on the south side of the garage (photo 13). Corroded stair treads, landings, stringers and guardrails were also observed at the stair towers; however, the corrosion at these locations was not as severe (photo 14).

13
Corroded
stair treads,
stringers
and
guardrails

7. Corroded stair treads and stair stringers at stairway connecting ground-level and lower-level of parking garage should be replaced due to observed delamination of the steel. Steel delamination is indicative of significant section loss and warrants replacement.

Estimated Area of Steel Tread Replacement: 100 SF

Estimated Length of 12" Steel Stringer Replacement: 50 LF

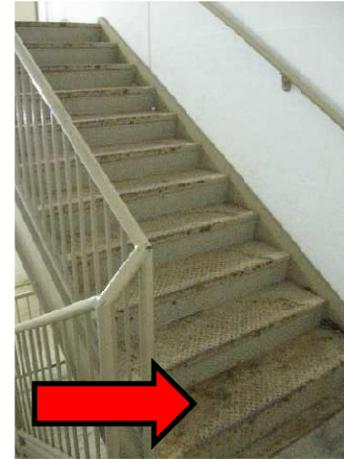
14
Corroded
stair treads
at stair
towers

Stair treads and stringers at the stair towers were lightly corroded; however, it is LEI's opinion that no structural repairs are required at these locations at this time. LEI recommends that the stair treads and stringers be cleaned and painted with a rust-inhibitive paint.

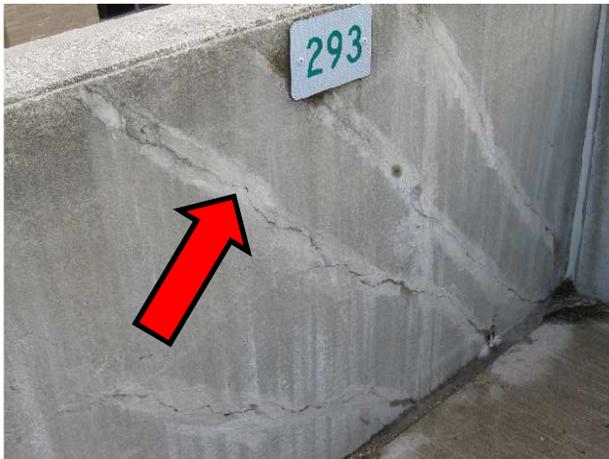
8. Forty-five degree shear cracks were observed at the ends of the precast spandrel panels on the north wall at the upper garage level. Some of the cracks appear to have been sealed or repaired at some point in the past (photo 15). Similar cracks were also observed at a spandrel beam on the north wall at the lower garage level.

15
45-degree
cracks at
spandrel
panel

8. Diagonal shear cracks at spandrel panels should be epoxy injected with an approved epoxy-injection repair compound to prevent water infiltration. It is LEI's opinion that the cracks are not indicative of a structural deficiency; however, the cracks should be sealed to prevent water infiltration and further widening of the cracks which could result in structural damage over time.

Estimated Length of Epoxy-Injection Repair: 650 LF

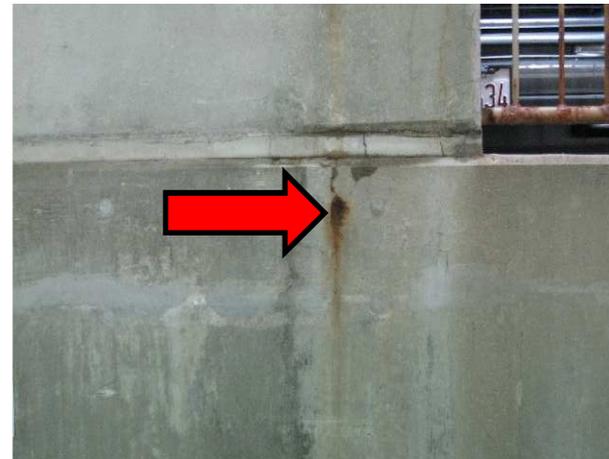
9. Local areas of exposed and corroded rebar were observed at multiple locations on both the interior and perimeter concrete walls (photo 16). We also observed local areas of exposed and corroded rebar in the precast double-T beam flanges when viewing the flanges from the end of the member (photo 17).

16
Exposed
and
corroded
rebar at
wall

9. Local areas of exposed, corroded rebar at concrete walls and at double-T beam flange ends should have all loose concrete elements removed and rebar should be cleaned and any corrosion removed. Exposed rebar should then be primed and painted with a rust-inhibitive paint. The concrete should then be sealed or patched with an approved sealant or patching compound.

Estimated Area of Rebar Repair: 20 SF

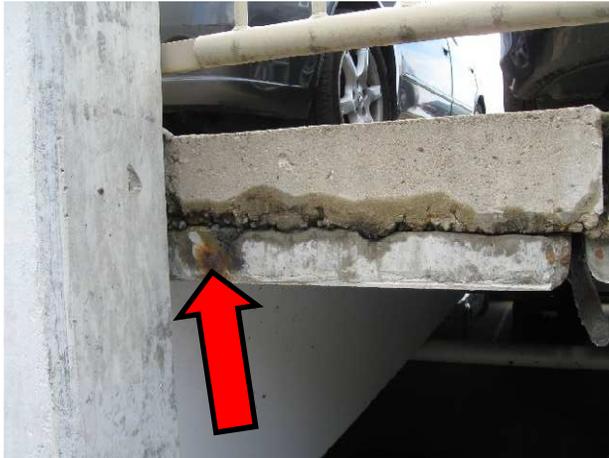
17
Exposed
corroded
rebar at
precast
double-T
beam
flange

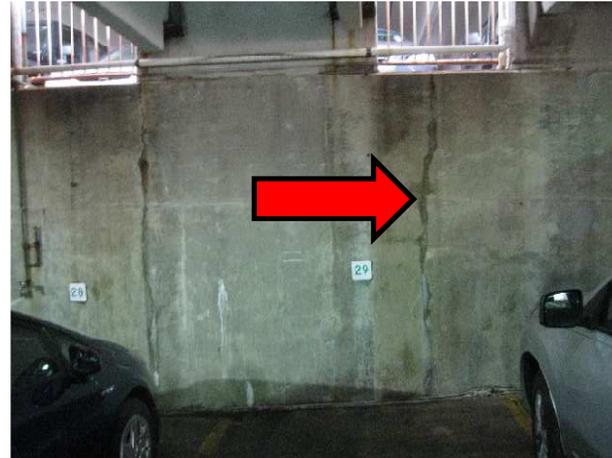
10. A crack in the west interior precast wall at the upper level of the garage was observed. Shrinkage cracks at the top of the foundation wall were observed at multiple locations along the center walls of the garage. Cracks in the foundation walls were also observed in multiple locations (photo 18).

18
Cracks in
foundation
wall

10. Cracks in the foundation walls should be epoxy injected with an approved epoxy-injection repair compound to prevent water infiltration. It is LEI's opinion that the cracks are due to shrinkage of the concrete and are not indicative of a structural deficiency; however, the cracks should be sealed to prevent water infiltration and further widening of the cracks which could result in structural damage over time.

Estimated Length of Epoxy-Injection Repair: 325 LF

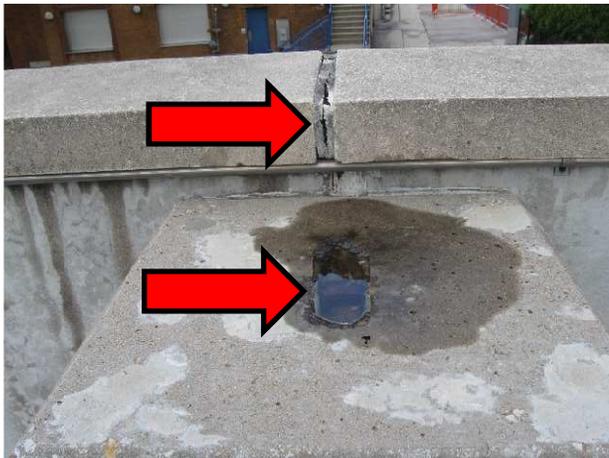
11. We observed minor chips and spalls at various locations on top of the concrete deck and at the concrete coping. Local areas of spalled concrete were also observed at several columns and interior walls; each area of spalled concrete was smaller than 3 square feet, and rebar generally was not exposed (photo 19).

12. Damaged or deteriorated sealant and open sealant joints were observed at multiple locations at the concrete coping panels (photo 19). Open sealant joints were also observed

19
Spalled
concrete
and open
sealant
joint at
coping

11. It is LEI's opinion that the minor chips and spalls observed at various locations at the top of the concrete deck, the concrete coping, and at multiple columns and interior walls where rebar are not exposed are not indicative of a structural deficiency and do not require a repair at this time.

12. See Recommendation #1 for sealant repair requirements.

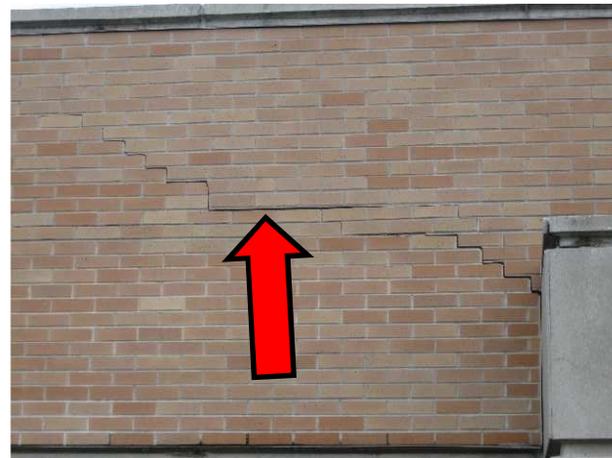
13. Several areas of deteriorated mortar were observed at the brick façade on the southwest sign tower. Step cracks were observed at the brick façade on the south and west faces of the parking garage (photo 20).

20
Step-cracks
at brick
facade

13. Areas of deteriorated mortar at the brick façade on the southwest sign tower should be repointed. Repointing should be applied at all locations of cracked, loose, missing or

deteriorated mortar. Proper repointing should include the contractor grinding out existing mortar prior to pointing with new mortar that matches the existing mortar. The step-cracks observed on the south building façade and the resulting open mortar joints appear to be caused by differential deflection of the supporting spandrel relative to the adjacent column. Pointing the open joints in this area will result in wider mortar joints at the step-crack locations which may not be aesthetically acceptable. If this is the case, this section of the brick façade will need to be removed and replaced. LEI has not included the replacement of this section of the brick façade in this report.

Estimated Area of Repointing: 20 SF

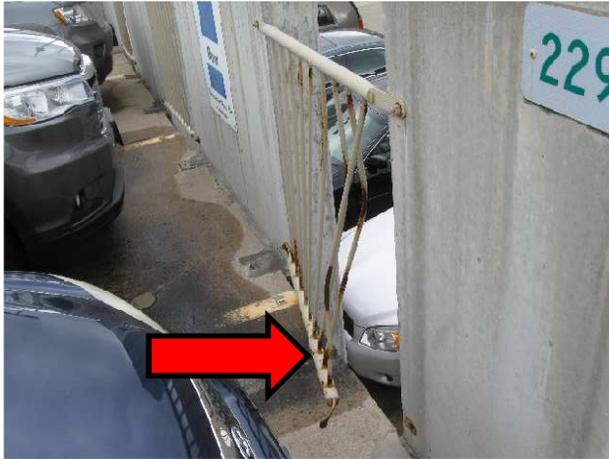
14. Varying levels of corrosion were observed at the guardrails that run along the centerline of the parking garage on both the upper and lower levels, as well as at the guardrail that runs along the lower north garage wall. At one location on the upper level of the garage, a guardrail was damaged and was partially detached from the garage structure (photo 21).

21
Corroded
and
partially
detached
guardrail

14. Excessively corroded or damaged guardrail segments should be replaced.

Estimated Length of Guardrail Replacement: 40 LF

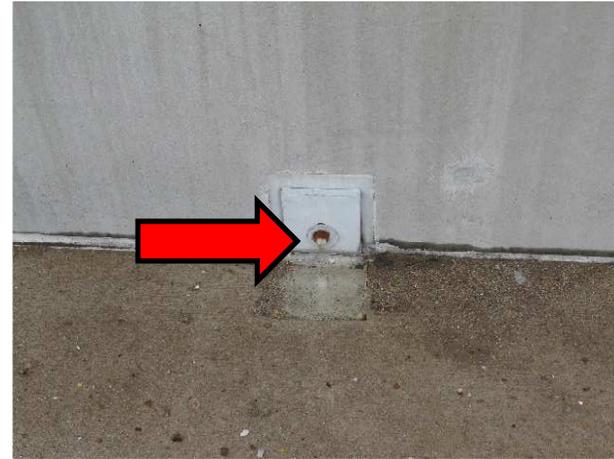
15. Anchor bolts were corroded at multiple locations at the northeast section of the upper garage level, as well as at one location at the ground level south garage wall (photo 22).

22
Corroded
anchor bolt

15. See Recommendation #6 for anchor bolt repair/replacement requirements.

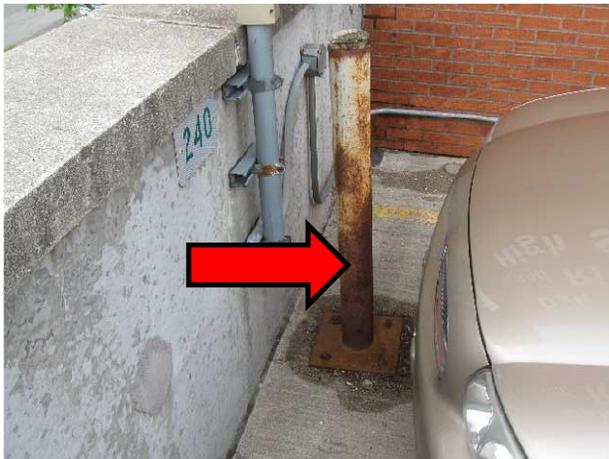
16. Three (3) corroded bollards were observed at various locations within the parking garage (photo 23).
 17. The door and elevator frames at the northeast and southeast stair towers were corroded (photo 24). The door frames at the northwest and southeast mechanical room entrances were also corroded. We also observed deteriorated sealant at the door frame on the upper level northwest stair tower. The paint on the steel canopy at the northeast stair tower on the upper level was peeling and chipping (photo 25).

23
Corroded
bollard

16. Corroded bollards should be cleaned and any corrosion should be removed. Exposed steel should be primed and painted with a rust-inhibitive paint.

Estimated Quantity of Bollard Replacement: 3 EA.

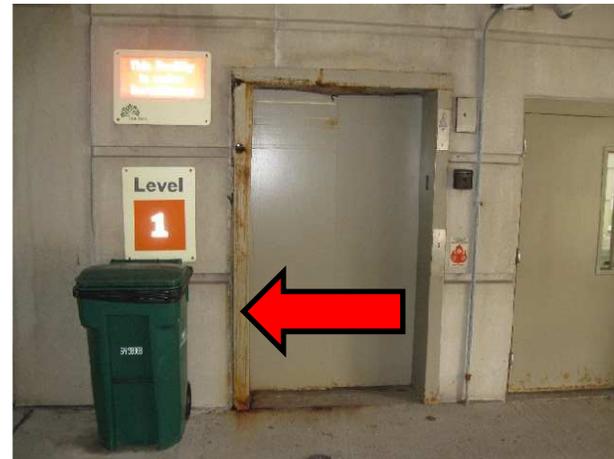
24
Corroded
elevator
frame

17. Corroded door and elevator frames should be cleaned and any corrosion should be removed. Door and elevator frames should then be primed and painted with a rust-inhibitive paint to prevent further corrosion.

Estimated Area of Scrape/Prime/Paint at Door Framing: 15 SF

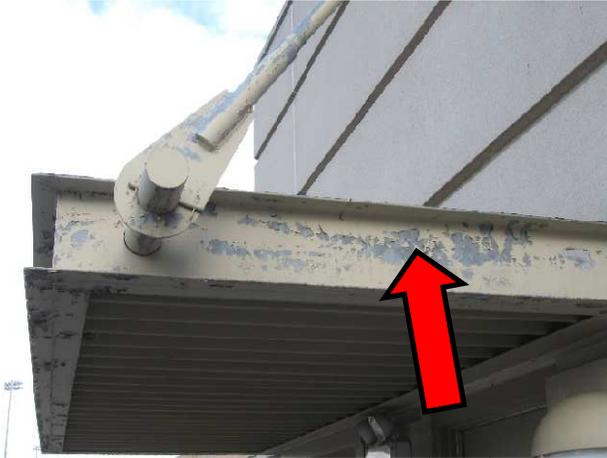
25
Peeled
paint at
canopy

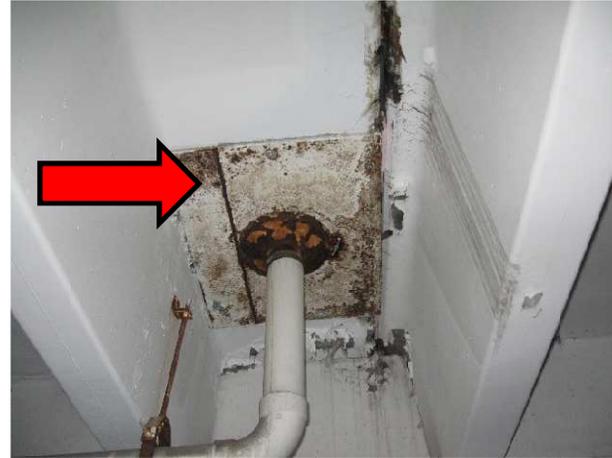
18. In two (2) locations a corroded steel plate was observed at the underside of a drain location (photo 26). Corroded mechanical and electrical conduits were also observed at the west end of the lower garage level (photo 27).

26
Corroded
plate at
drain

18. Replace corroded steel plates at drain locations.

Estimated Quantity of Steel Plate Replacement (Approx. 10x10x1/8" Plate): 2 EA.

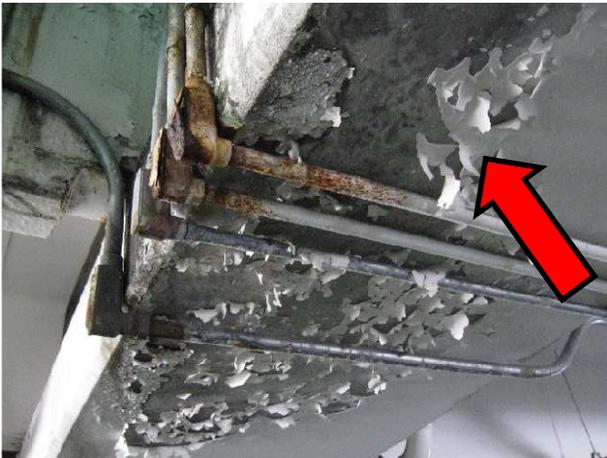
27
Corroded
conduit and
water
damage

Replace corroded conduit.

Estimated Length of Conduit Replacement: 30 LF

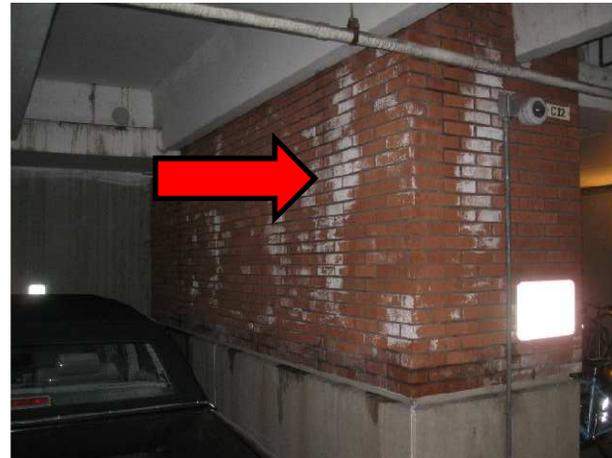
19. Areas of efflorescence were observed at the brick façade at the interior face of the southeast utility room as well as at the interior face of the southwest sign tower (photo 28).

28
Efflorescence
at brick
facade

19. Areas of efflorescence should be cleaned and removed.

Estimated Area of Efflorescence Removal: 130 SF

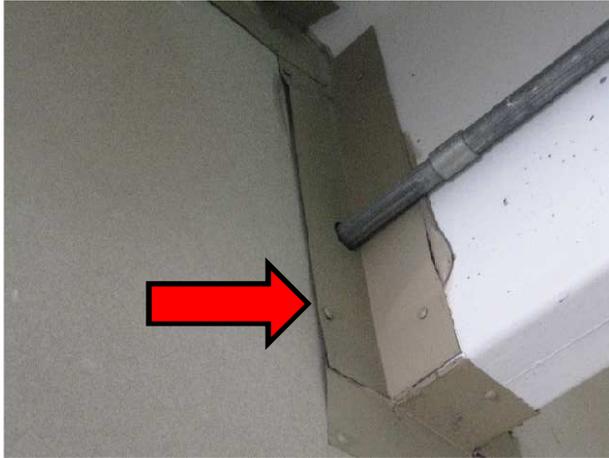
20. Where the precast double-T beams penetrated the façade of the northeast and northwest stair towers, flashing was observed around the perimeter of the T-beam penetration; however, no sealant was observed at the flashing (photo 29).

29
Flashing
with no
sealant at
beam
penetration

20. Sealant should be applied around flashing at double-T beam penetrations.

Estimated Length of New Sealant: 15 LF
